SITAF - SFTRF

*First aid intervention in the tunnel of Frejus
on December 11, 1999*

Firs aid intervencion carried out during the drilling operation of the resque staff of SITAF and SFTRF in the inside of the Tunnel of the Frejus on December 11, 1999 since 23.20 h up to 24.10 h approx.

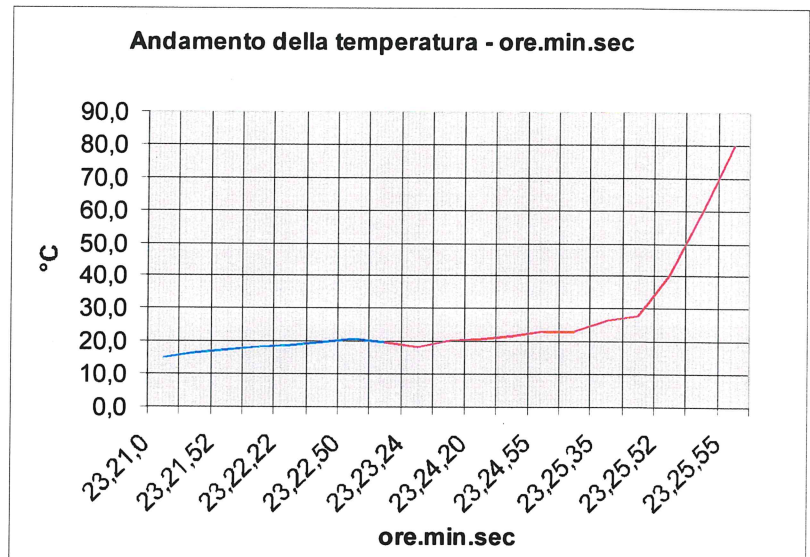
Fig.1:

This graphic represents the trend of temperature inside of tunnel depending on the elapse from the tunnel entry up to the fire point.

- Poor visibility inside of tunnel obscured by smoke after 3200 m approx from the entry from Italy-France side
- Temperature inside of tunnel going from 15°C up to 80°C as shown in the graphics of figures 1 and 2
- Flame temperature 550°C approx.

On the ground of the recording carried out during the rescue drilling, it was possible to chart the graphics shown at figures 1 and 2 which represent the heat propagation from the tunnel entry - on the Italy side - up to the fire point. The temperature resulting on the fire site was of 80-90°C approx., while the flame temperature was of 550°C approx.

These graphics represent the heat propagation from the fire point situated at 7500 m approx. From the Italy-France side towards the tunnel entry on the Italy side. The meters travelled in absence of smoke are blue-colored, while those travelled with a visibility obscured by smoke at 10 m. Approx. Are red-colored.

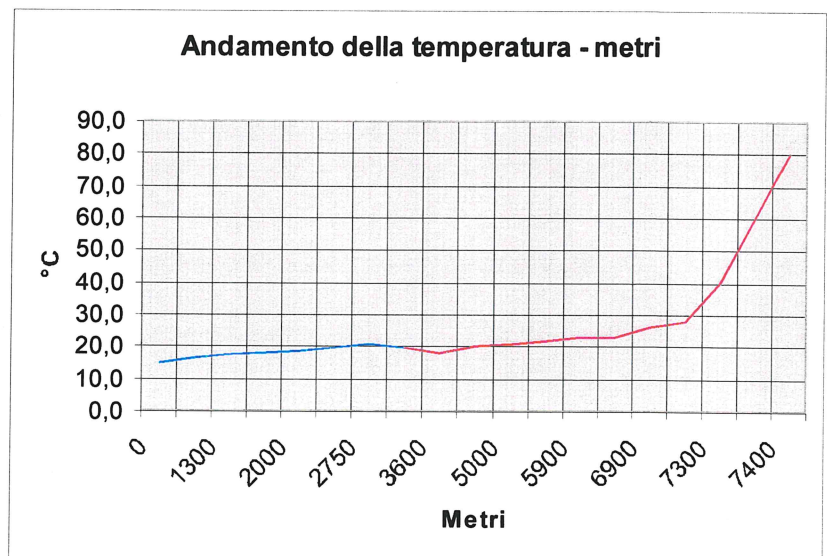
Fig.2:

This graphic represents the trend of temperature inside of tunnel depending on the meters travelled from the tunnel entry up to the fire point. (An average speed of car of 90 km/h has been considered)

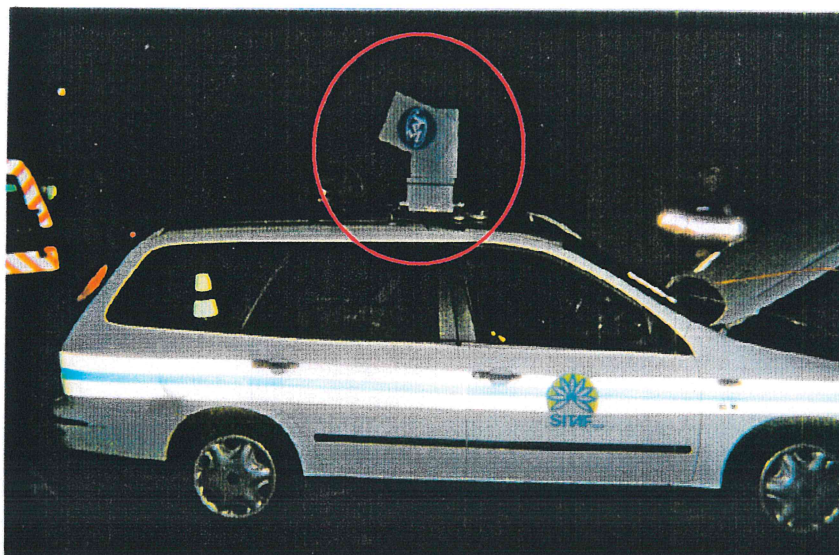
Fig.3:

The integrated SAI-PTR/1 System has been installed rapidly on a service car of SITAF.

The integrated SAI-PTR/1 System is equipped with pan&tilt traverse to offer a higher checking of thermographic sensor SAI-FPA/1.

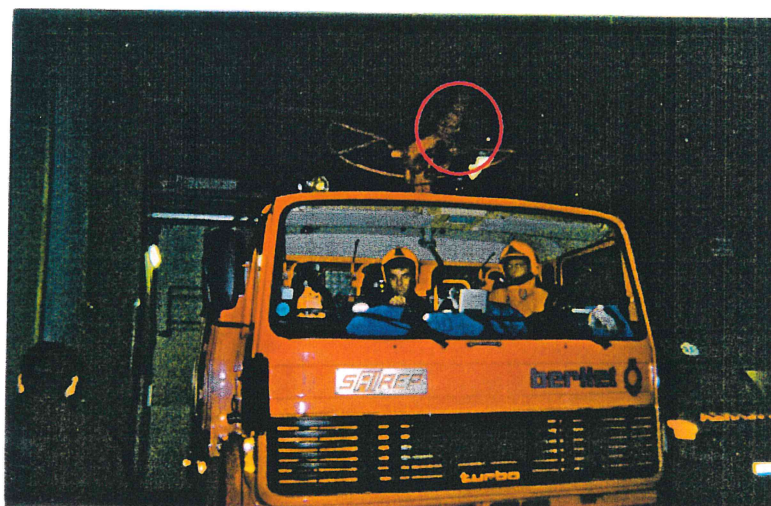
Fig.4:

The integrated SAI-PTR/1 system has been installed above the extinguisher turret of a fire fighting rescue car of SITAF.

Thanks to the infrared system installed above the extinguisher turret of the rescue car, it was possible to reach the fire locality in an efficient and rapid manner, by overcoming all obstacles dislocated along the route.

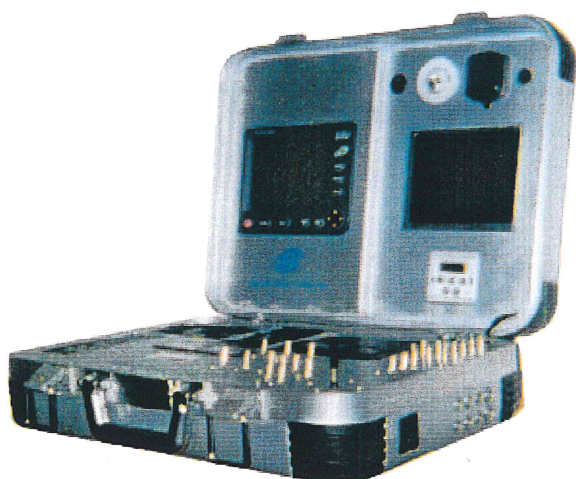
Fig.5:

The SAI-TLC/1 unit is fit for checking of thermographic sensor SAI-FPA/1 and pan&tilt traverse. It is besides equipped with an integrated GPS positioning system near the digital recording systems.
